Application of the ultrasonic transmission tomography for inspection of the petroleum tank floor

R. Raišutis, R. Kažys, L. Mažeika, R. Šlīteris

Ultrasound Institute, Kaunas University of Technology, Lithuania

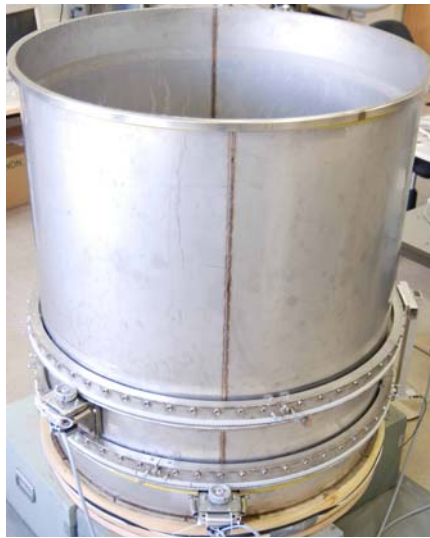
Fig.2. Photo of the 1:8 scaled down size tank mock-up (a) and the measurement set-up (b) used for investigation

For experimental investigation the scaled down size tank mock-up (scaling factor 8:1) placed on wet sand and filled with water was selected (Fig.2a). The internal diameter of the tank was 1 m, the height 1.1 m, the thickness of the floor plate was 1 mm. The experimental set-up used in the investigation and the plates arrangement of the welded floor is presented in Fig.2b.

The transmitting ultrasonic transducer was mounted on the edge of the plate. Data acquisition was performed by the measurement system developed in the Ultrasound Institute of Kaunas University of Technology. The excitation pulse frequency was 400 kHz, the number of the rectangular burst cycles was 3. The excitation voltage of the transmitter was 200 V and the gain of the receiver was 50 dB. The receiving transducer was mounted on the edge of the tank floor (flange). The signals propagating through the tank floor were recorded. The fundamental A_0 , S_0 and the multiple mode conversion signals have been observed. The mode conversion (A_0 mode to S_0 and opposite) take place at each weld of the bottom plate and on the weld between the floor and wall plates.

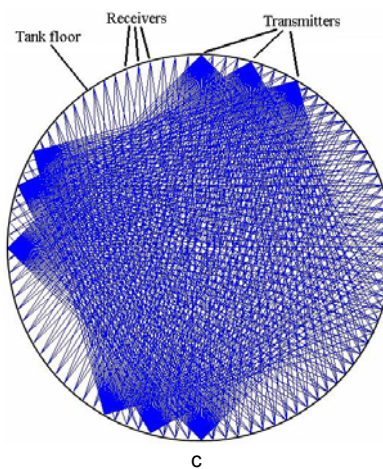
Fig.5. Application of the transmission tomography for inspection of a petroleum tank floor: a - photo of the real tank, which is necessary to inspect, b - experimental set-up, c - the transmitter and receiver positions during *in situ* experiments

In order to estimate the performance of the developed reconstruction algorithm, the experimental measurements have been carried out *in situ* on a small 8 m diameter tank (Fig.5 a), with the step 25 cm along the circumference of the tank floor. The total number of measurement points was 441. In the measurements 50 kHz ultrasonic transducers were used. The transducers were attached to the edge of the tank floor using liquid coupling and magnetic fixing. The tank floor edge was prepared in advance by grinding. For the signal excitation and reception the ultrasonic imaging system developed by the Ultrasound institute of Kaunas University of Technology was used (Fig.5 b). The transmitters were excited using the three periods burst.

In such a way the number of projections was acquired. The projection in the ultrasonic transmission tomography is assumed to be the distribution of the attenuation versus transmission direction or angle (Fig.5 c) for one transmitter position. In our case the transmitter was attached to the edge of the tank floor on one side and receivers were placed at different points on the opposite side of the tank floor covering approximately 180° sector. At each position from the acquired signals the relative attenuation (losses) are measured. The other projections are acquired in a similar way, only the transmitter is attached to the edge of the floor at different positions with some step from the previous one and the measurements on the opposite side of the tank in a corresponding sector are performed. In general, the tomography requires as much as possible of different projections, because the accuracy and resolution of the reconstructed images depend on the number of projections. On the other hand, the accuracy depends on the wavelength of the exploited Lamb wave. So, the optimal number of projections should be determined for each particular case. During investigations 9 tomographic projections were acquired (Fig.5 c). To increase reliability and reduce a noise at each point 11 measurements were performed.
