Non-destructive inspection of aircraft landing gear during residual strength testing.

A. Urbah, M. Banov, S. Doroshko, V. Turko

Riga Technical University, Institute of Transport Vehicles Technology;

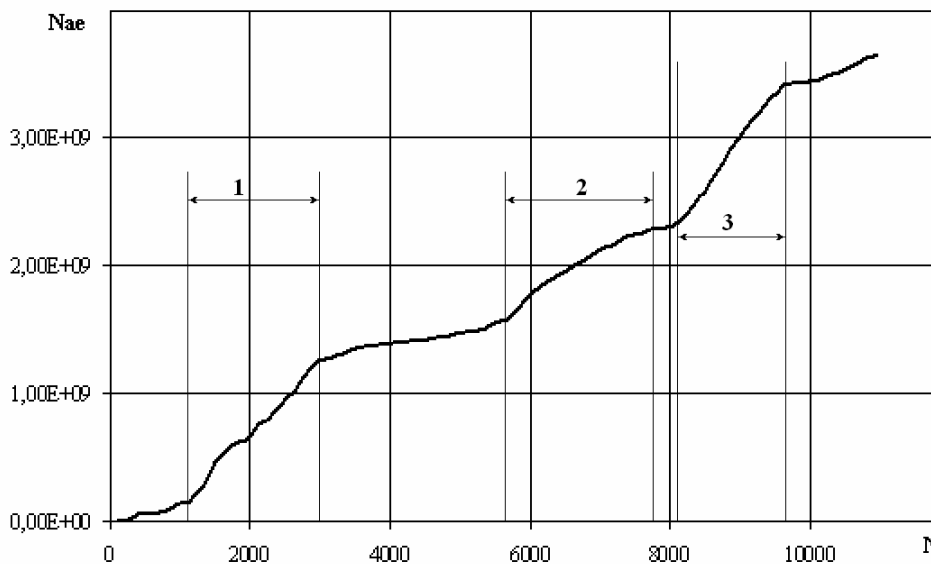
Some of the AE data are represented in Fig.1. This is a change of cumulative AE N_{AE} versus the loading cycle number N . It is possible to see that the graph has zones of fast and slow changes of N_{AE} . Several zones are where the maximum changes of the AE parameter occur. There are 3 zones of maximum changes: zone 1, zone 2, and zone 3. It is usually possible to connect these changes with principal steps of a failure development. There is known a concept of staged development of a fatigue crack[1, 2]: for

example, for 3-stege variant a microcrack transforms to a mezzo and then to a macrocrack. According to this concept, the zones marked in Fig.1, may be interpreted by a following way. There is a zone of microcrack appearance and its initial development (zone 1), a zone where the microcrack is transformed to a macrocrack (zone 2) and a zone of macrocrack development (zone 3). Therefore, the fatigue crack grows at different velocities: the periods of slow crack growth, where energy of destruction is

Fig. 1. Cumulative AE N_{AE} versus loading cycle number N : 1, 2, 3 – zones of N_{AE} maximum changes

These results confirm the main conclusion of AE checking. Actually, according to Fig.1, the moment of a crack initiation is located in the beginning of the zone 1 (1200 cycles approximately). Then, it is possible to observe a decrease of the cumulative AE N_{AE} growth at the ends of the marked zones: the end of zone 1 is approximately 3000 cycles; the end of the zone 2 – approximately 7700 cycles; the end of zone 3 – approximately 9800 cycles. Besides, according to the AE data it is possible to determine that the macrocrack began in the range of 8000...8500 cycles.

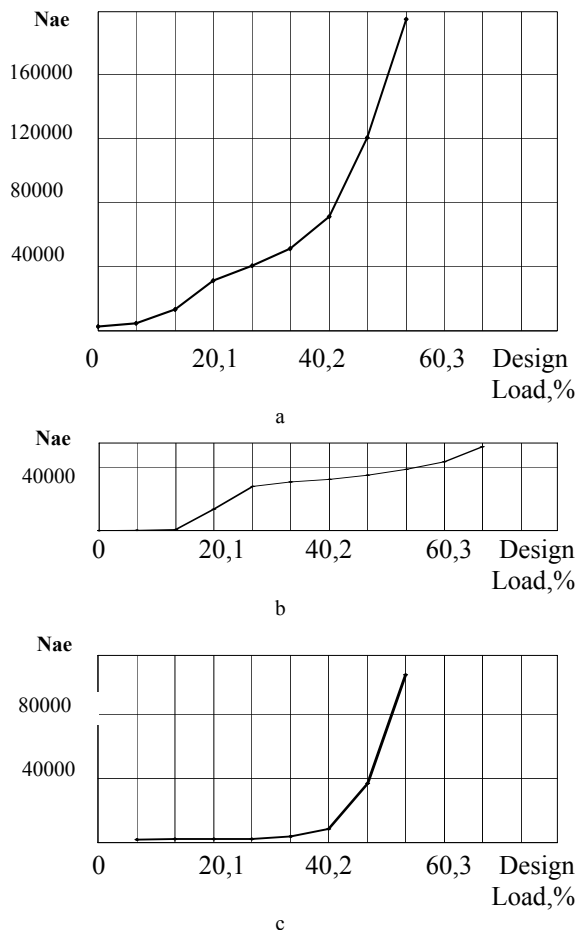
The eye disruption happened when the load was equal to 52.7%. This disruption began from the fatigue crack which grew during the previous testing and developed in the inner cylindrical surface of the eye hole. However, the AE control shows (see, Fig.2a) that cumulative AE N_{AE} started increasing when the load was equal to approx. 40% of the maximum load. Most probably the fatigue crack begins to move at this moment in time.

Fig. 2. N_{AE} versus design load: a - during “ M_y – axle beam torsion” loading program; b - “braking during landing” loading program; c - “standard flight” loading program

The loading variant „running with landing weight” was a final step of a fatigue testing of the residual strength. Besides, the additional M_y is summed with the main load. The stepped loading was used as before. When the load was between 46.9% and 51.5% of the calculated-destroyed load the disruption of the second cross-piece of the lower hinge occurred. AE check showed that the disruption began when the load was equal to approx. 40% (see, Fig.2c).

During the residual strength tests the AE data (Fig.2 and Fig.3) may be used for earlier information about disruptions. It is important, because it gives the opportunity to observe the failure development and prevent stand destroying during testing.

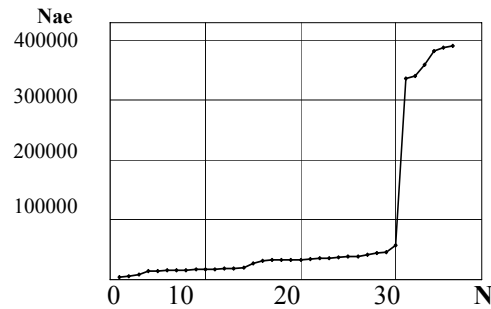
However, the sharp growth of the cumulative AE was stated (see, Fig.3) during the loading program component „turnings before take-off”. Probably it was the moment when a non-reversible disruption of the second cross-piece of the destroyed eye started. This conclusion is confirmed by the analysis of stress changes in the non-damaged eye of the lower hinge: the maximum M_y acted upon the eye this time.

Fig.3. N_{AE} versus N during „turnings before take-off” loading program.
