Detection of crack in a concrete element by impact-echo method

Abstract

Demonstrative experiment was done to verify ability of the impact-echo method to detect discontinuity, honeycombing or any defect in a concrete structure. Two beams of the length 7.5 m were investigated, the first one with an evident shear crack, the second one without visible deterioration. Observation confirmed assumptions and in the depth 2,0 m a discontinuity was detected.

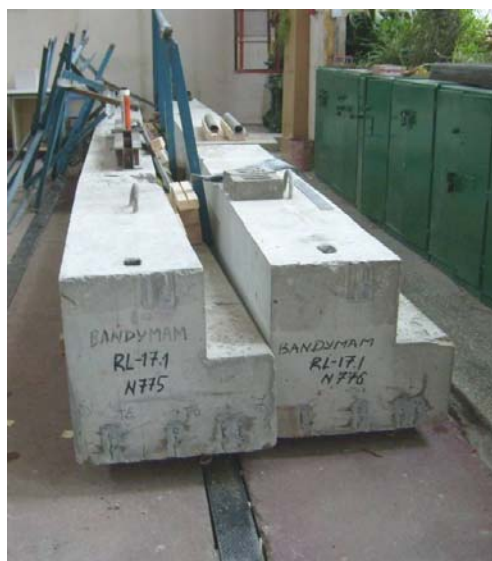
Fig 4. Foreheads of the two tested beams

Two reinforced concrete beams with dimensions (300/600 x 560 x 7500) mm were investigated to determine whether there is a crack or not (see Fig 4 and 5 – measurement points are marked by black arrows). The quality of the concrete was unknown and therefore the impulse velocity had to be verified. The range of velocities was taken from Table 1, the width of each beam was measured in situ (Table 2) and the expected frequencies were obtained again by from Eq. 1. After estimation of the expected values, the natural longitudinal oscillations measured in the transversal direction of the beam could be found easily and the real velocities of the transmitted impulse were computed by Eq. 1.

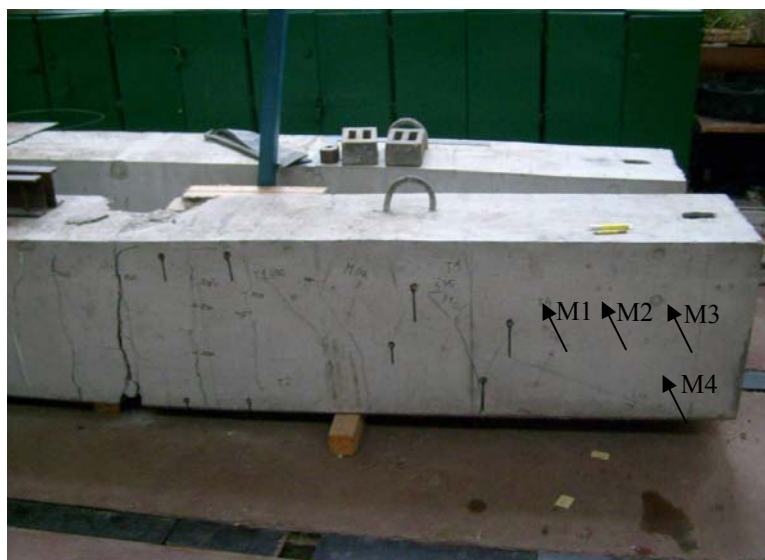
Fig 5. Tested beams in a longitudinal direction
