## Characterization of casting defects in composite carbon fiber material detected by ultrasonic inspection

V. Capitani, M. Capriolo, D. Seni

Non Destructive Testing Technological Laboratory, BYTEST Srl; 10088 Volpiano, Italy;

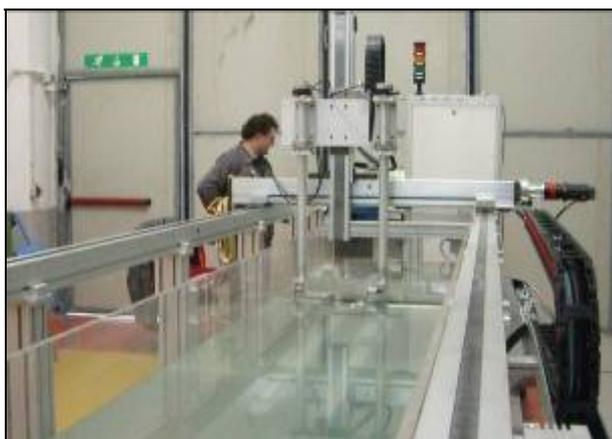
- Immersion ultrasonic system for control of parts in transmission or pulse-echo with three movement axes (Fig. 1).

Fig. 1. BYTEST immersion ultrasonic system

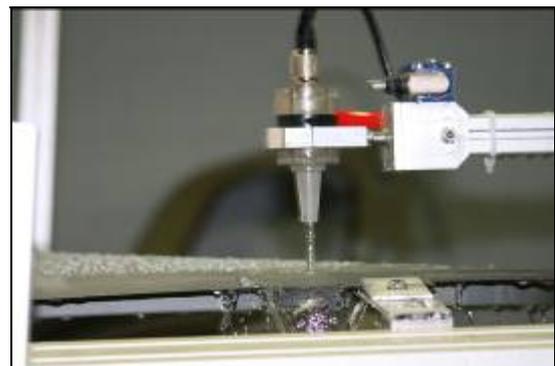
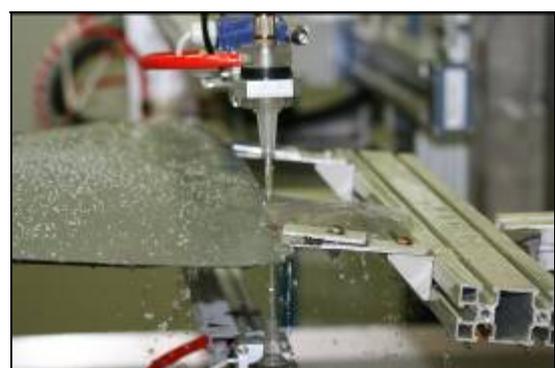
- Automatic ultrasonic system by water column for control of parts in transmission or pulse-echo, with four axes of movement, for structures with complex geometry (Fig. 2).

Fig. 2. BYTEST water column ultrasonic plant

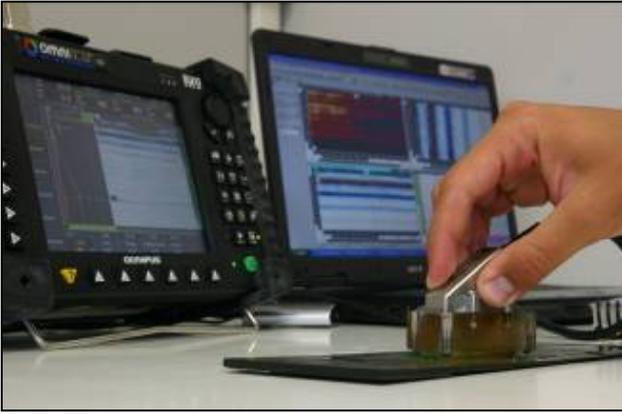
- Semi-automatic system with phased array technology (Fig. 3), which offers the possibility to create and manage an ultrasound beam in terms of angles, focal lengths and

sections of the beam. The equipment generates an ultrasound beam through the excitation of a series of piezoelectric elements (64 active elements), which can be managed independently by inserting a series of parameters concerning the number of elements used (size of the beam UT), the angles of inspection and the depth of focus, compared to the depth of the object to be inspected.

Fig. 3. Phased Array semi-automatic system

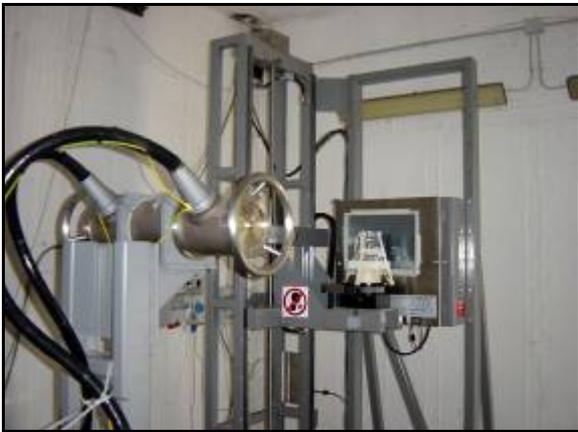
- Inspection system with X-ray Computed Tomography (CT), which allows 3D digital reconstruction of a particular, allowing it to be thoroughly inspected by virtual sections (Fig. 4).

Fig. 4. BYTEST computed tomography plant

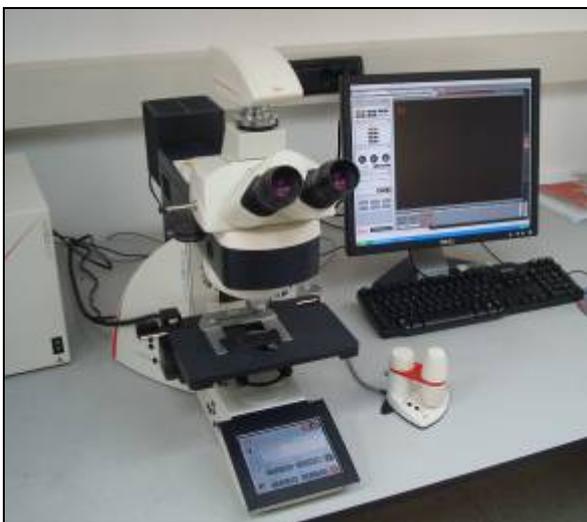
- Leica digital microscope DM6000. This microscope is used with all common incident-light methods (bright field, dark field, polarization, interference contrast, fluorescence contrast), with engine scan table, also used in fully automated mode and in conjunction with an image analyzer (Fig. 5).

Fig. 5. Digital Microscope Leica DM6000

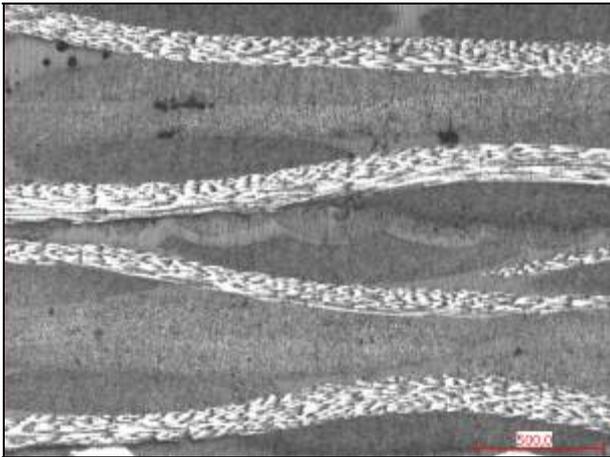
Fig. 6. Micrographic evidence to 50X cross-section of a sample with evidence of both elongated and isolated porosity areas

its integrity. In fact, many specifications require that the polymering process guarantees a number of voids in the volume does not exceed 1% or 2% (Fig. 6, Fig.7). Normally, the porosity content is measured as a percentage of the volume of the laminate, making the determination on a sample obtained from a cross section of the same considering in the overall evaluation the size contribution of each individual detected porosity. When the distance between individual pores is less than 3 mm we can speak of substantial presence of porosity that, to the level of acceptance standards must be treated as an actual delamination.

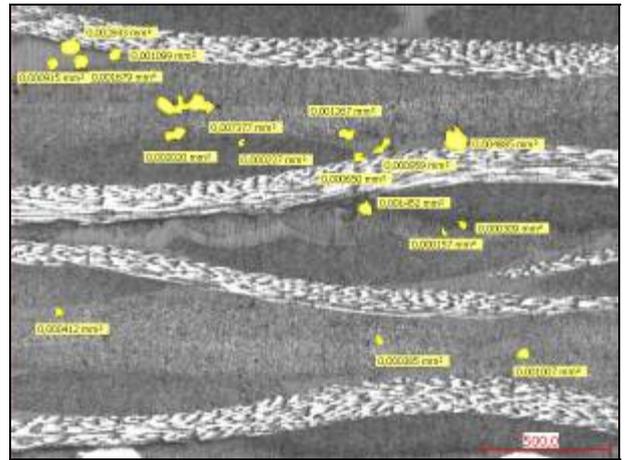
Fig. 7. Evidence of dimensional measurements of each porosity made on sample to the side by image analyzer

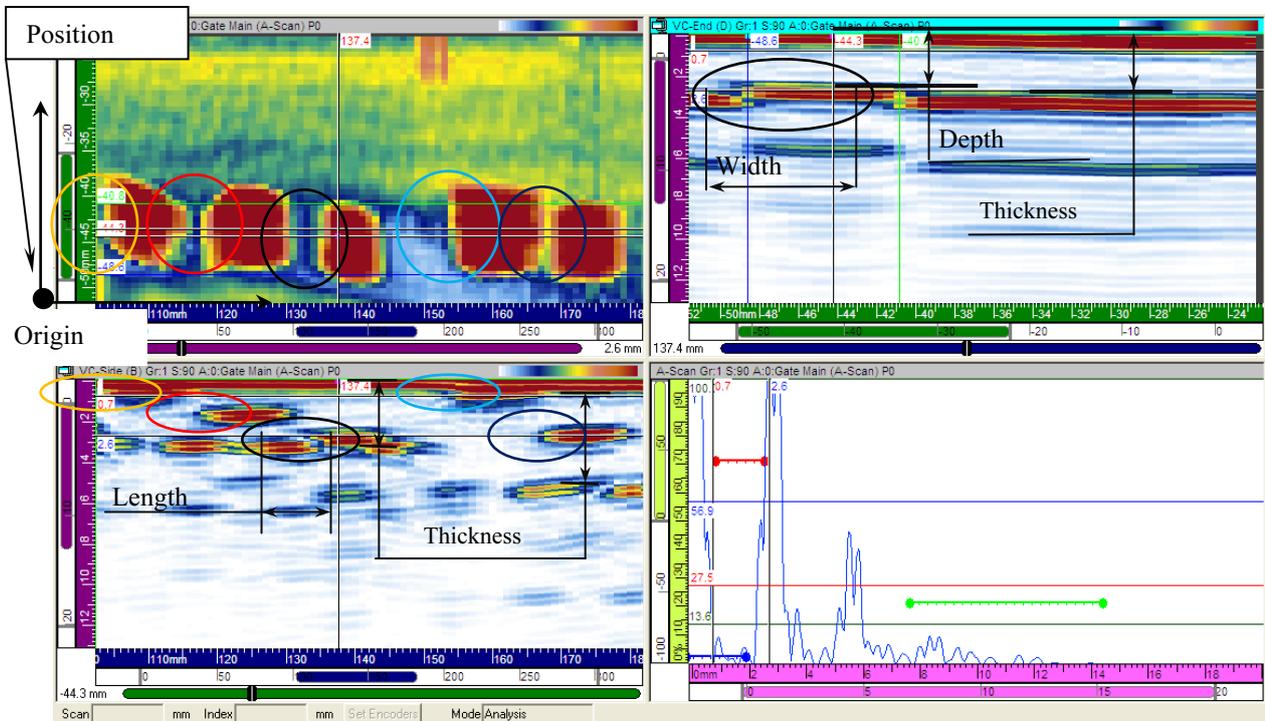
The reference sample is constructed with the same process of the tested particular with inside the volume a series of artificial discontinuities of different materials and sizes, placed in critical areas and different depths to simulate delaminations (Fig. 8).

Fig. 8. Reference standard representation

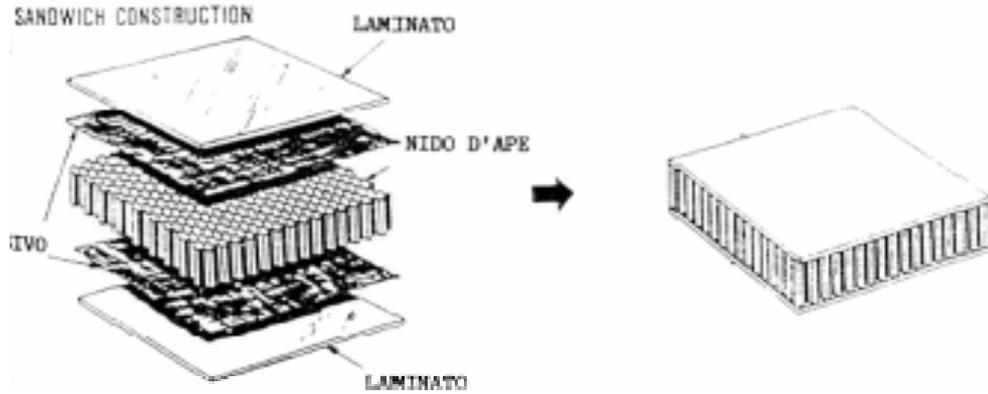
Honeycomb structures are usually carried out by inserting between two skin of carbon of variable thickness, a honeycomb structure (also of variable thickness) joined

together through one or more adhesive lines. Typically, the adhesive consists of a thin film cut to size smoothly covers the entire bonding area.

Fig. 9. Honeycomb structure

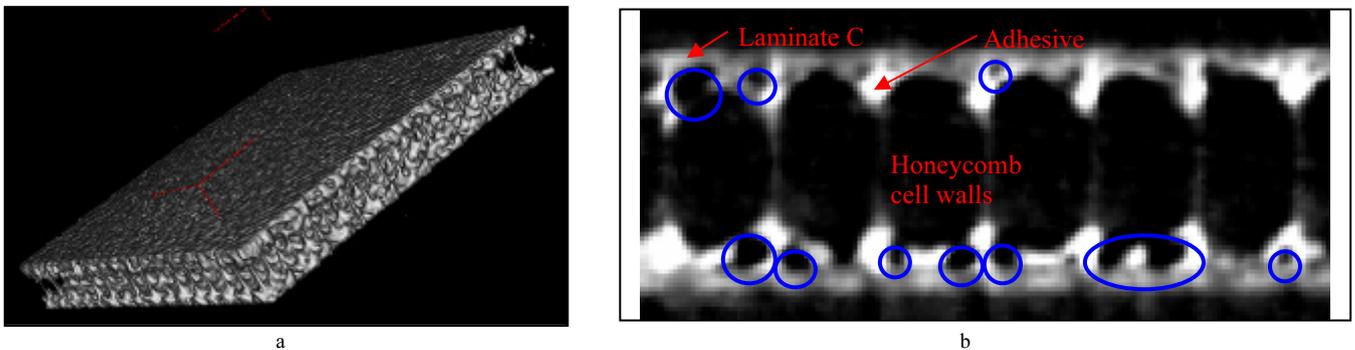
Even the breaking and crushing of honeycomb can generate an interruption in the continuity of the structure and so must be detected in ultrasonic inspection. A typical casting defect in the line of adhesive is the porosity (Blue area in Fig. 10a, b). The presence of air bubbles generated during polymerization causes a significant change in the amplitude of the ultrasound signal.

Fig. 10. a – CT specimen, b – frontal section CT specimen with porosity areas

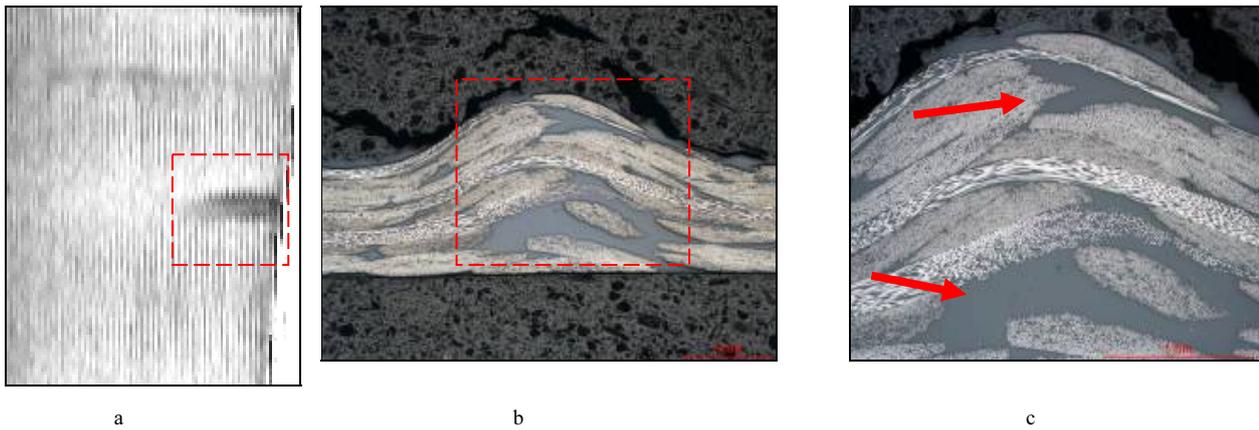
Fig. 11. a – c-scan representation in amplitude, b – micrographic evidence to the wrinkle 25X, c - detail of the same at 50X (See dashed area in the previous photo). The arrows indicate areas with the highest concentration of resin.

by ultrasonic inspection, generating an attenuation of the ultrasonic signal due to their geometrical shape. In fact, within these is to form an accumulation of resin, which compensates for the swelling caused by the wrinkle itself.

By sectioning and embedding of a micrograph specimen in these areas, you get the photographic evidence of the sinuous trend of skins which confirms the absence of other structural anomalies such as porosity or delamination compared with a high structural fill factor by resin so that compensates for the variation in thickness in that area. These type of discontinuity is evaluated by Visual and dimensional inspection.

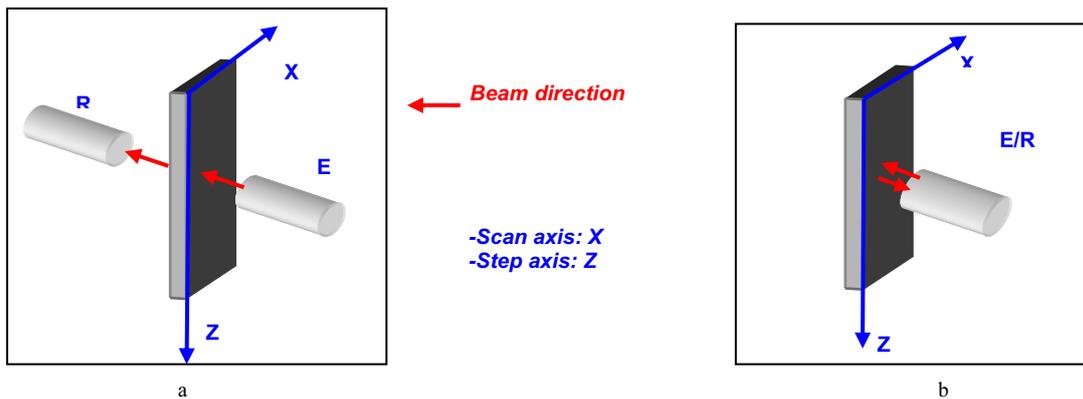
Ultrasonic techniques for the detection of these discontinuities may be pulse-echo or through transmission, as illustrated in Fig. 12a ,b.

Fig. 12. a – pulse-echo technique, b - through transmission technique

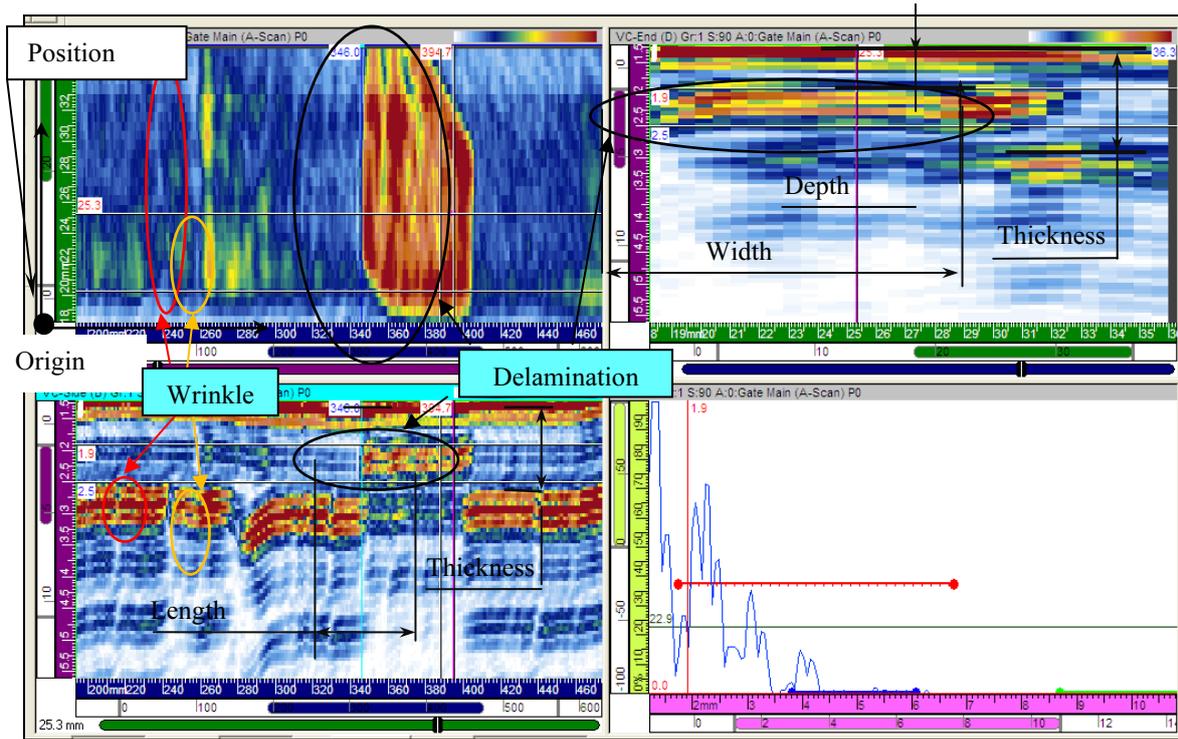
Fig. 13. UT phased array representation

acquisition data by performing the analysis and the possible image processing (Fig. 13).

The analysis performed with a phased array system allows with the help of the acquired image processing (full wave) to be in possession of all the information about the detected discontinuities, such as depth, length, width, orientation and position relative to the origin point of the scan.

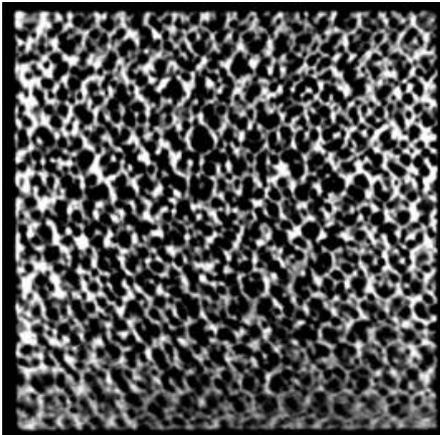
Fig.16. CT section sandwich structure

The performed acquisition analysis revealed the presence of porosity in the line of adhesive at the interface between solid laminate and honeycomb cells. Both lines of adhesive (Fig. 16) had the porosity but in the spindle side had a significant preponderance (Fig. 17).

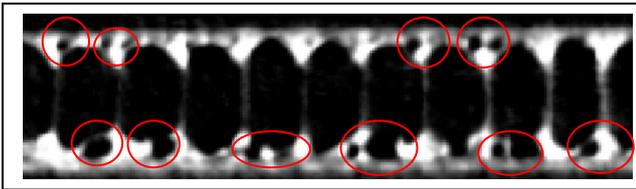
Fig. 17. CT section of the line of adhesive with porosity

○ - porosity in the line of adhesive

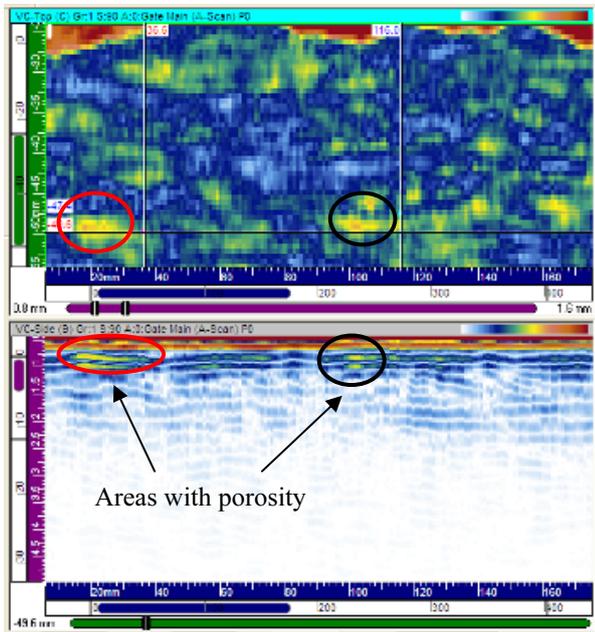
Fig. 18. ○ ○ - areas with porosity

Through the application of pulse-echo phased array technique is possible to have a C-scan representation able to appreciate where is present an area with the higher presence of porosity.
