Application of air – coupled ultrasonic technique for sizing of delamination type defect in multilayered materials

E. Žukauskas, V. Cicėnas, R. Kažys

Prof. K. Baršauskas ultrasound institute

Kaunas University of Technology

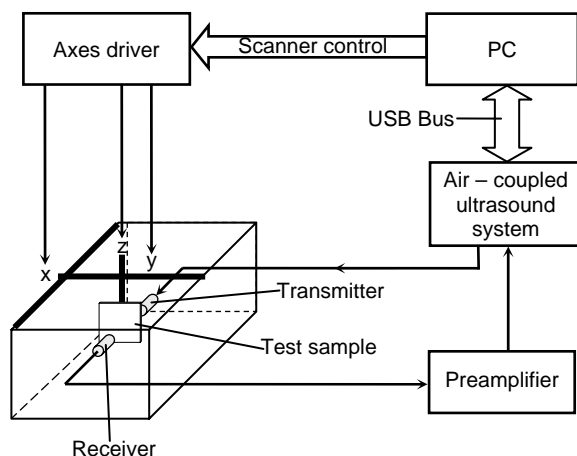
Fig.1. Block diagram of the experimental system

The whole system is controlled using personal computer. Two channel air-coupled ultrasonic system consists of the high voltage generator, the low noise amplifier and the analog – to – digital converter. The maximal output voltage of the generator is 750 V. Gain of the amplifier can be changed from 10 dB to 50 dB. The low noise 13.4 dB preamplifier is connected directly to the receiver in order to improve the signal to noise ratio.

The block diagram of the experimental system is presented in Fig.1.

Experimental signals are collected and stored in the PC. Also there is possibility to real time presentation of B – scans and amplitude C – scans.

The scanning system is designed in such a way that the ultrasonic transducers are at the fixed position and the test sample is moved during the scanning process by a spatial step 0.1 mm. Scanning was carried out using the 445 kHz air - coupled focused piezocomposite transducers in the through – transmission mode. The focal spot of the transducers is 1 mm.

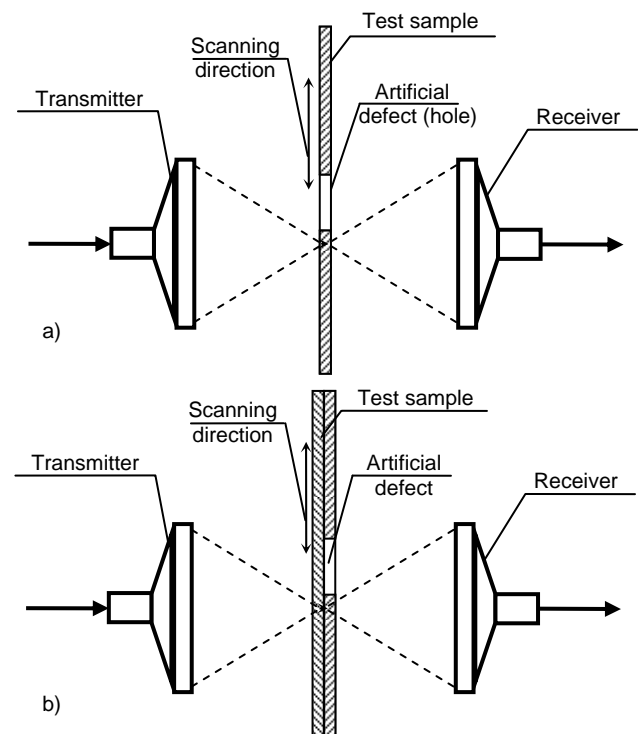
Fig.2. Test samples: a- scanning of the single layer test sample; b- scanning of the test sample with a bonded additional aluminum sheet

Experiments were performed using two types of the test samples: the reference test sample and carbon fiber reinforced plastic (CFRP) test sample. The reference test sample was produced from 0.6 mm aluminum sheet. As the defect 6×6 mm square hole was made. The CFRP test sample contains inner artificial delamination defects made of folded and sealed teflon. The size of the defect is 6×6mm.

Experiments were carried out using two configurations of the reference test sample: scanning of the single layer test sample (Fig.2a) and scanning of the double layer test sample with an additional aluminum sheet of the same thickness which was bonded using grease (Fig.2b).

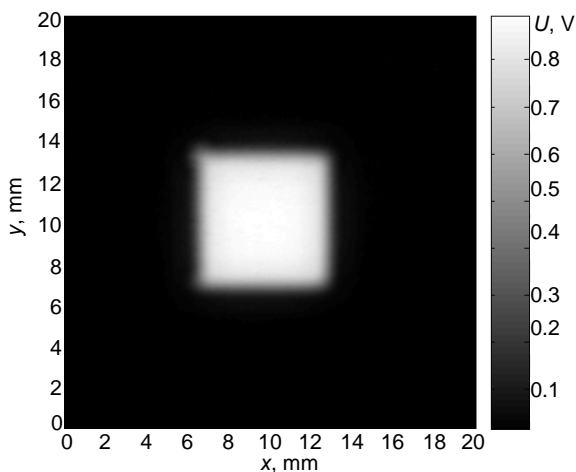
Fig.3. Amplitude C – scan of the reference test sample

The amplitude C – scan of the single layer reference test sample is presented in Fig.3. Due to the high signal to noise ratio the defect can be easily distinguished without averaging of the signals.

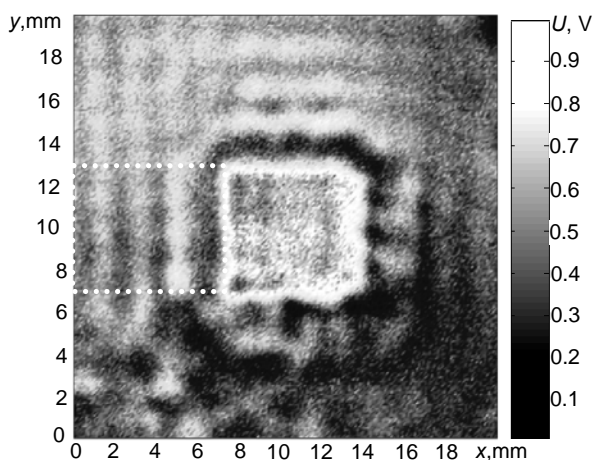
Fig.4. Amplitude C – scan of the test sample with the bonded additional aluminum sheet

The amplitude C – scan of the test sample with an additional bonded aluminum sheet is shown in Fig. 4. Due to low signal to noise ratio the experiment was carried out using signal averaging. 32 signals were averaged at each scanning step. Periodical fluctuations of peak to peak amplitude of collected signals were noticed around the defect. To explain this phenomenon, simulation of the wave propagation through the aluminum test sample was performed. The simulation results are presented in the next chapter.

To get the clearer signal from the experimental results the average signal was taken. The averaging was performed using the results of experimental measurements of C-scan. The signals from $y=7.5$ mm to $y=12.5$ mm (Fig.4) was combined by averaging along one line (Fig.9). Modeling results of the same zone are presented in Fig.10.

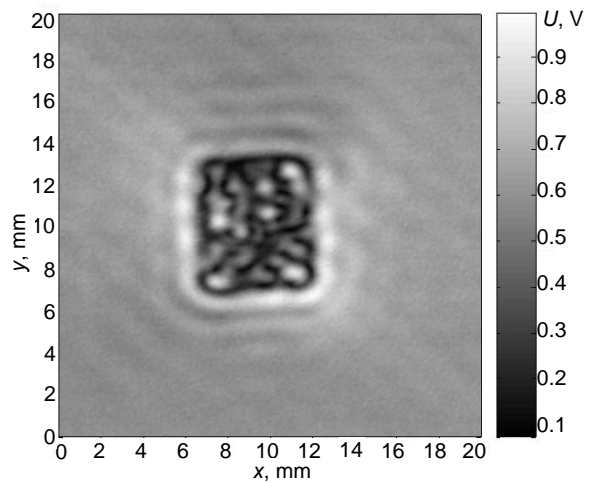
Fig.5. Amplitude C – scan of the CFRP test sample with an artificial delamination defect.

The amplitude C – scan of the CFRP test sample with the artificial delamination defect is shown in Fig. 5. Experiment was carried out using signal averaging due to the low signal to noise ratio. 32 signals were averaged at each scanning point. Periodical fluctuations of the peak to peak amplitude of the signals around defect were noticed as well as in the previous experiments. Some bright spots are visible in the area of the artificial defect. Origin of these spots can be explained by bonding of the defect to the carbon fiber reinforced plastic.

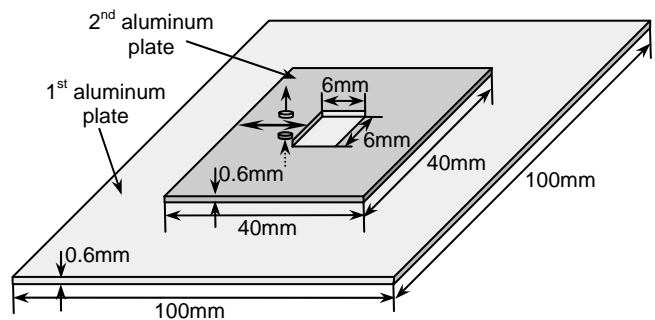
Fig.6. The configuration and the dimensions of two bonded aluminum plates

The finite differences Wave3000 Pro software package was used to create the 3D model of the bonded aluminum plates in order to simulate wave propagation through these bonded plates. The model consists of two aluminum plates bonded together: the first is the 100x100 mm square shape and 0.6 mm thickness plate, the second plate is of the same thickness and 40x40 mm dimensions with the 6x6 mm square hole at the centre (Fig.6).

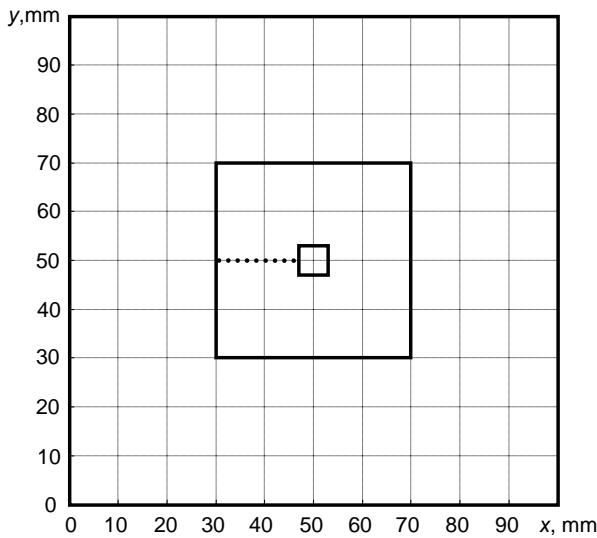
Fig.7. Wave300 Pro model and marked axis of modeling

The following parameters used in the simulation were selected: the excitation frequency 445 kHz; the excitation signal nine periods burst with the Gaussian envelope. The simulation was carried out at the plane $y=50$ mm, scanned

region from $x_1=30.5$ mm to $x_2=46.5$ mm, with the scanning step 0.25 mm (Fig.7).

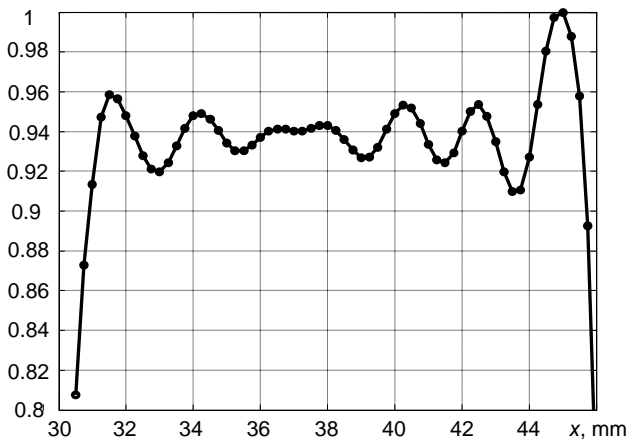
Fig.8. The simulation results (acoustical pressure) obtained by the finite difference model. The simulated region is from 30mm to 46.5mm

The normalized modeling results are presented in Fig.8. Normalization of the simulation and experimental results were performed according to maximal value of the results. The oscillations amplitude near the edge of the second aluminum plate is larger and then decreases moving farther from the edge. The reason of these oscillations is due to the finite dimensions of the test sample, the direct signal and the signal reflected by the nearest edge overlap. The spatial oscillation period is quite close to the half wavelength of the a_0 mode ultrasonic Lamb wave which in our case is 2.2 mm.

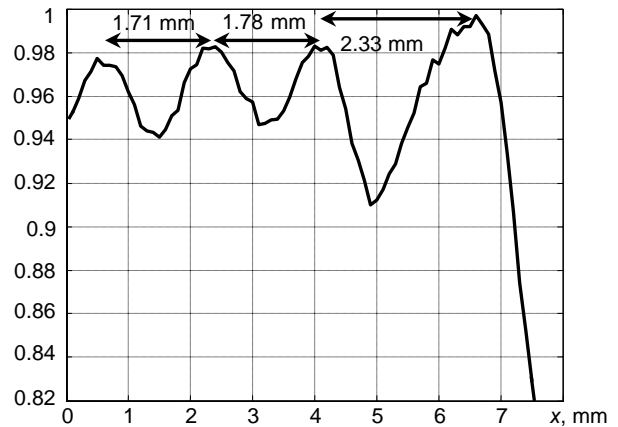
Fig.9. The averaged measurement results; normalized amplitude of the signal versus coordinate

Fig.9 and 10 show that modeling results corresponding to the experimental. The coordinate x corresponds to the dimension of the aluminum sample used in the experiments.

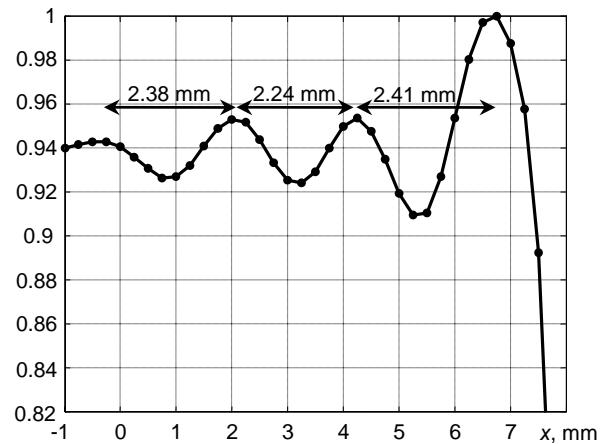
Fig.10. Modeling results; normalized acoustical pressure versus coordinate.

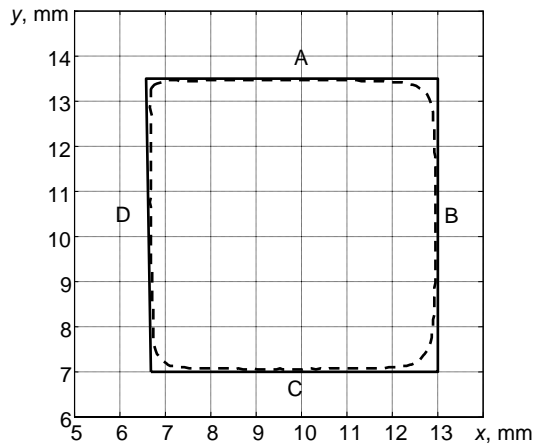
Fig.11. Cross – section of the amplitude C – scan at the -6db level (dashed line) and the dimensions of the defect measured using the optical microscope (solid line)

The cross section of the amplitude C – scan of the single layer aluminum test sample at -6 dB level is shown in Fig.11. In the same figure the defect dimensions, measured using optical microscope MBS - 9 are presented. In order to estimate accuracy of the measurements, the distance between the opposite sides of the defect mock - up was measured. Corners of the contour are rounded due to the finite dimensions of the transducers focal spot.

The calculated distances between the opposite sides of the defect from the measurement results are presented in Fig.12 and 13. The rounded areas of the corners were not taken into account. The mean distance measured by the air-coupled ultrasonic technique between A and C sides of the defect (Fig.11) is 6.39 mm. The standard deviation of the measurement results is 17.7 μ m. The distance between the sides A and C, measured by the optical microscope is 6.5mm. The measurement error is -0.11 mm or 1.7%. The mean distance measured by the air-coupled ultrasonic

technique between *B* and *D* sides of the defect (Fig.11) is 6.24 mm. The standard deviation of the measurement results is 27.19 μm . The distance measured by the optical microscope is 6.35 mm. In this case the measurement error is -0.11 mm or 1.7%.

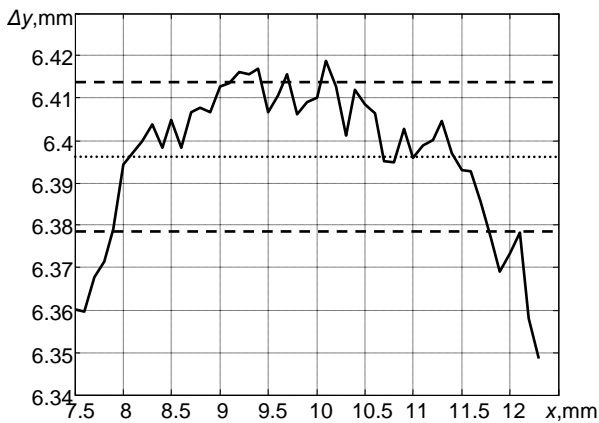
Fig.12. Measured results of the distance between A and C sides of the artificial defect along x axis. The mean value is 6.39mm (dotted line), the standard deviation is 17.7 μm (dashed line)

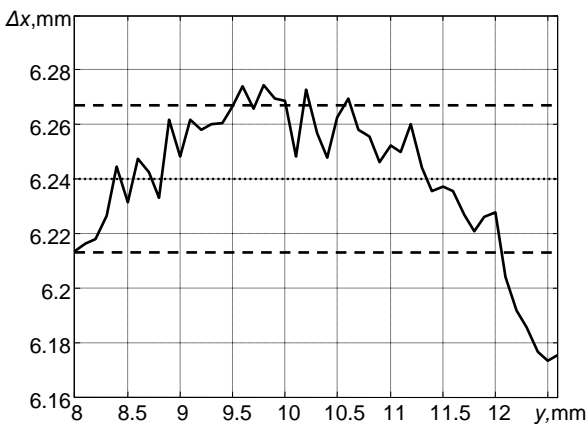
Fig.13. Distance between B and D sides along y axis. Mean value 6.24mm (dotted line), standard deviation 27.19 $\cdot 10^{-3}$ mm (dashed line). (zoomed x axis)

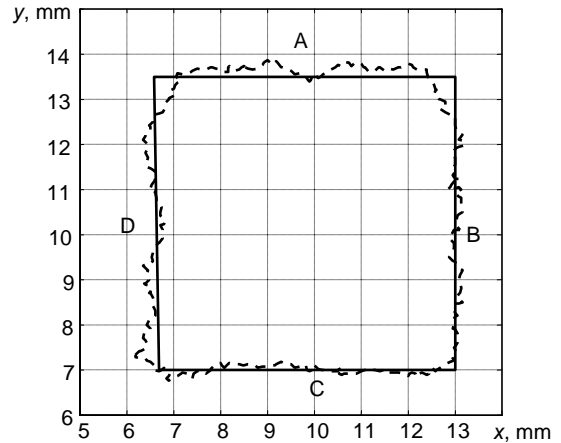
Fig.14. Cross – section of the amplitude C – scan at the -6db level (the dashed line) and dimensions of the defect measured using the microscope (the solid line)

The cross – section of the amplitude C – scan of the double layer aluminum test sample at the -6 dB level and results of measurements using the optical microscope are presented in Fig.14.

As well as in the previous case the rounded areas of the corners of the defect were not taken into account. The mean distance measured by the air – coupled ultrasonic technique between the opposite A and C sides of the artificial defect is 6.64mm. The measurement error is 0.14mm or 2.1%. The mean distance between the B and D sides of the defect is 6.47mm. The measurement error is 0.12mm or 1.9%. Due to the low signal to noise ratio the standard deviation of the measurement results for the double layer test sample is 0.13mm.

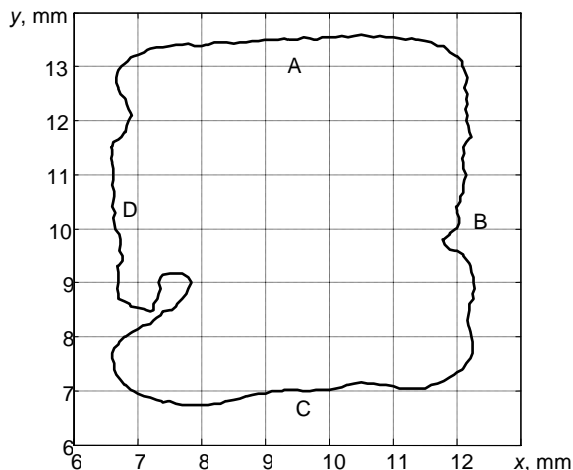
Fig.15. Cross – section of the amplitude C – scan of CFRP test sample at the -6db level dashed line and dimensions of the defect measured using microscope (solid line)

The cross – section of the amplitude C – scan of the CFRP test sample of the 1 mm thickness at the -6dB level is shown in Fig.15. The artificial defect lies in the 0.5 mm depth. The contour of the defect is distorted (B and D sides) probably due to bonding points of the defect at some points to the plastic material. These distorted sides were not taken into account in estimation of accuracy of the measurements.

The mean distance measured between the A and C sides of the artificial defect is 6.52mm. The measurement error is 0.52mm or 8%. The standard deviation of measurement results is 61 $\cdot\mu\text{m}$.

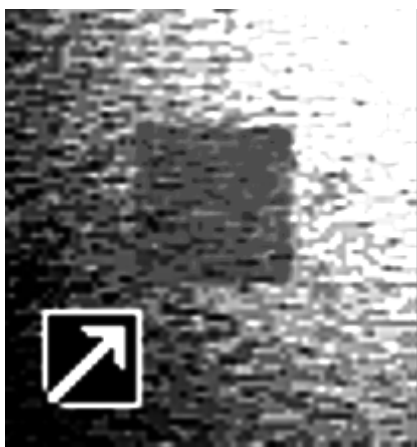
Fig.16. Radiographic image of the 6x6mm² artificial defect in CFRP test sample.

Because the defect is between the inner layers of the test sample, it was not possible to measure dimensions of the artificial defect using the optical microscope. The radiographic image of the CFRP test sample with the defect is shown in Fig.16. Due to low image quality it is almost impossible to measure dimensions of the defect. It is only known that defect dimensions should be 6 \times 6 mm.
